Ljubica Milović, Milorad Zrilić

FAILURE ANALYSIS OF ROTARY SCREW PUMP ANALIZA HAVARIJE ROTACIONE VIJČANE PUMPE

Stručni rad / Professional paper
UDK /UDC: 621.66-75
Rad primljen / Paper received: 27.09.2008.

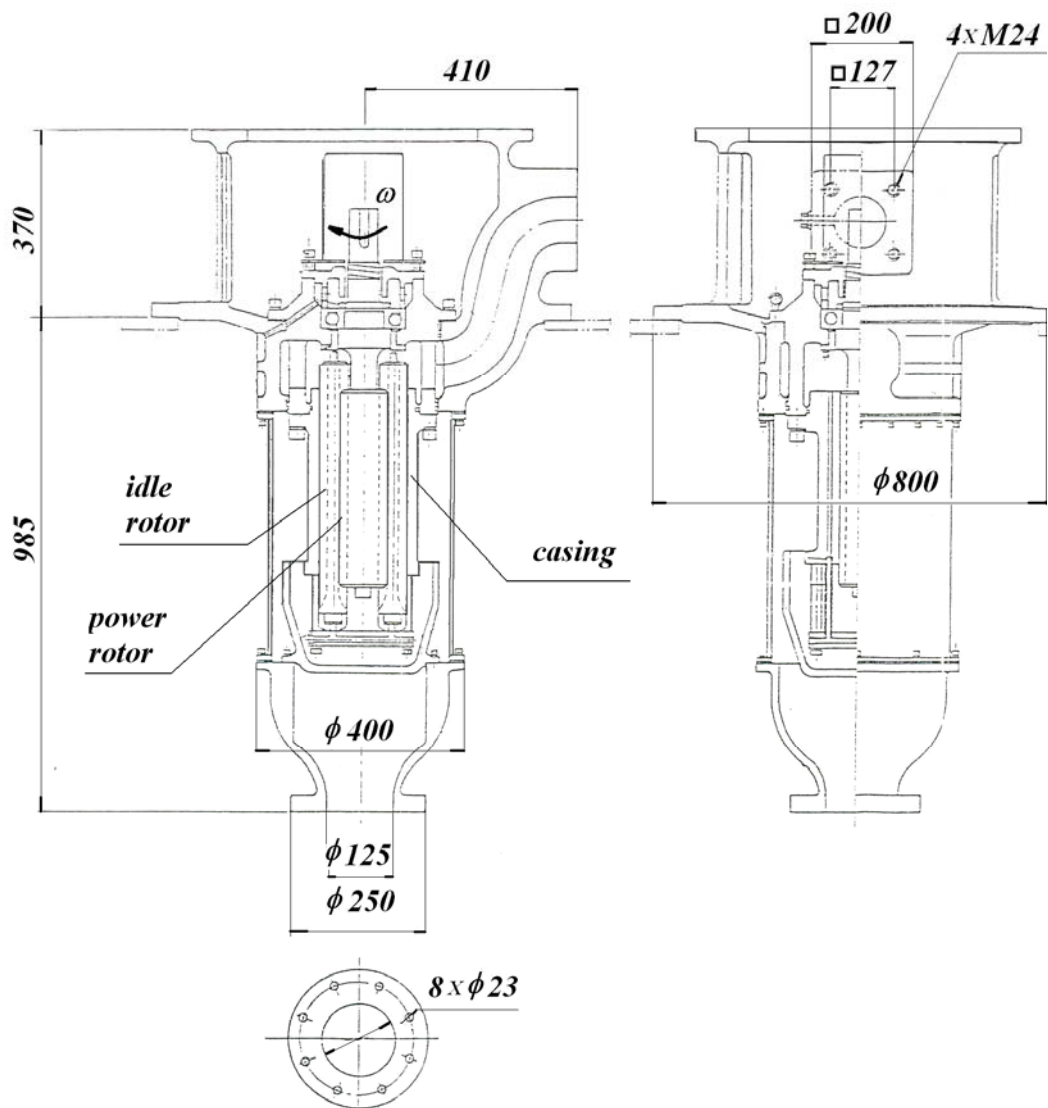
Figure 1. Assembly drawing of rotary screw high-pressure pump for regulatory oil.
Slika 1. Sklopni crtež rotacione zavojne pumpe visokog pritiska za regulatorsko ulje

Measurements had found that the length of worn surfaces of the power rotor and idle rotors corresponded to the casing length, Fig. 1. It was also revealed that the oil had changed its colour to black, indicating that the particles, resulting from the wear and tear of the power and idle rotor surfaces had blended with oil and penetrated the regulation system. As a result, oil temperature had increased and the pressure in relief valve had dropped, causing a distributor to open and pass the oil into the relief valve. Later on, the pump continued to operate for 3 hours, during which the oil was heated by a 20–30 kW heat source. Since the system was provided with filters (fine filter in front of converter

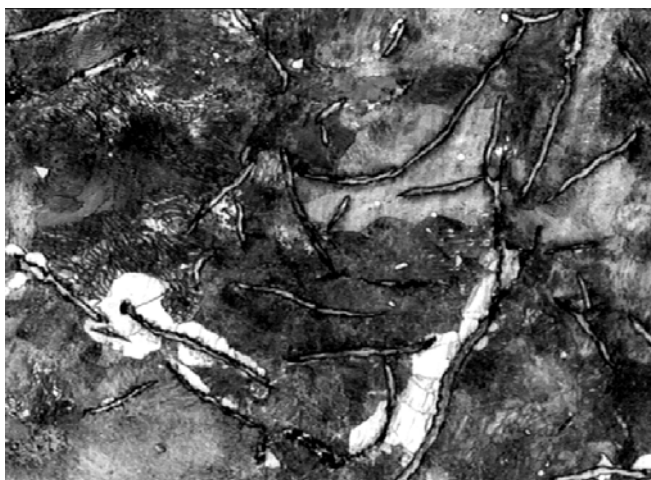
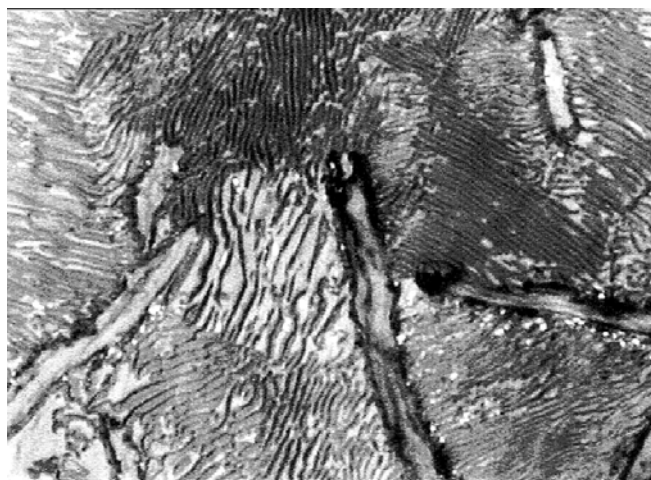
Figure 3. Microstructure of casing material, replica location R1.
Slika 3. Mikrostruktura materijala kućišta, replika na mestu R1

Metallographic analysis of R1 replica revealed a ferrite-pearlite structure of gray cast iron with lamellar pearlitic matrix in which graphite lamellae are segregated with a small amount of ferrite, Fig. 3.

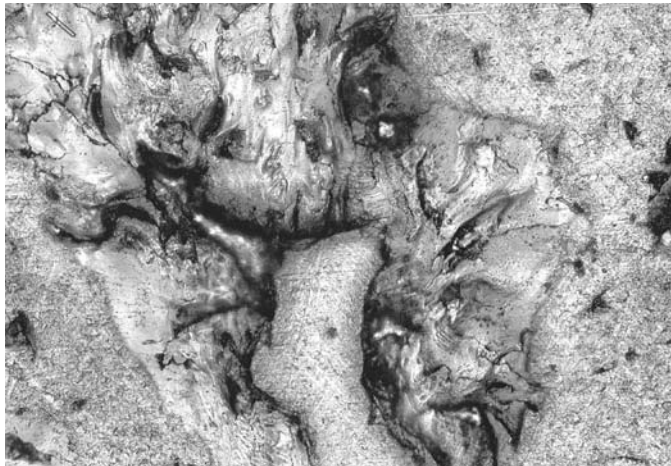
Figure 4. Microstructure of casing material, replica location R2.
Slika 4. Mikrostruktura materijala kućišta, replika na mestu R2

The examination of replica R2, taken in position of detected damage, revealed local deterioration as craters on very fine prepared surface, Figs. 4 and 5. The material is partially torn, i.e. small particles and pieces of casing material fell out. Weak bonds on metallic grain boundaries are most likely the cause, and may be the consequence of some

Revealed surface damages of the tearing type at typical locations of casing inner surface indicate that some deviation from normal operating regime of pump rotary parts

alloying elements segregating or accumulation of impurities in manufacture, or continuous use of the casing. On the other hand, the weakening of bonds may be provoked by diffusion of detrimental chemical elements from the environment, like hydrogen, oxygen or nitrogen.

occurred. Torn material particles had entered the oil stream flow and produced wear on all three gapping surfaces (between casing and rotors, at the bottom and on flank surfaces between power and idle rotors), thus producing a pressure decrease on the pump outlet.

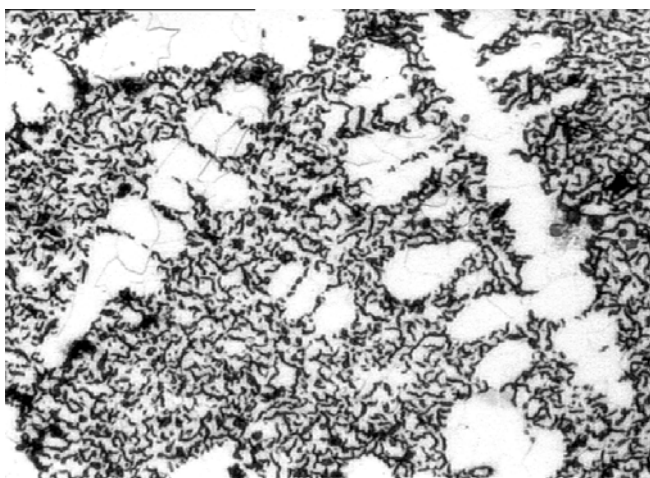
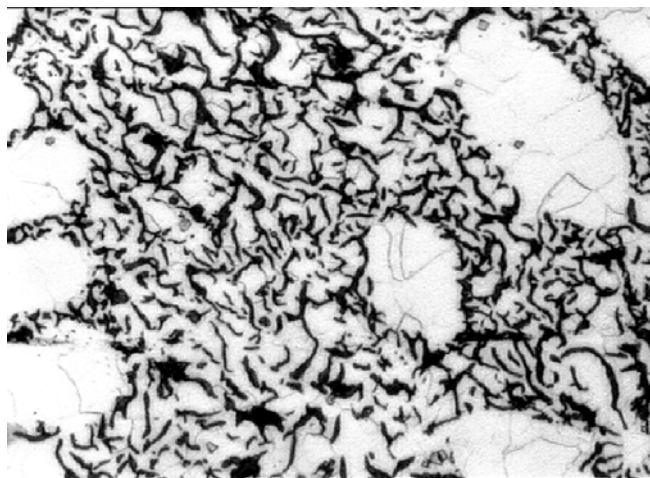
Figure 8. Micrographs taken from thread crown S2 and thread bottom S3 of idle rotor material.
Slika 8. Mikrografi uzeti sa spoljnje površine S2 i boka S3 zavojnice materijala slobodnog vretena

Figure 8 shows typical gray iron structure with presence of graphite eutectic containing silicon on specimens S2 and S3. The eutectic grows as cellular with fine graphite eutectic indicating higher cooling rate of casts. No differences in microstructure that can show eventual overheating of the material caused by friction and abrasion during the accident were noticed among tested positions of idle rotor.

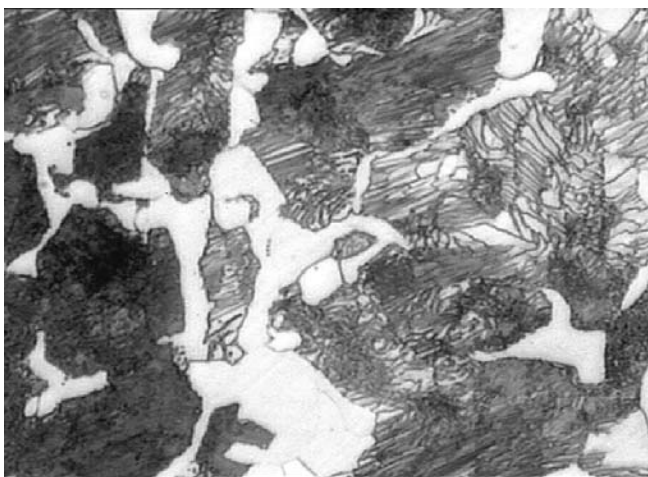
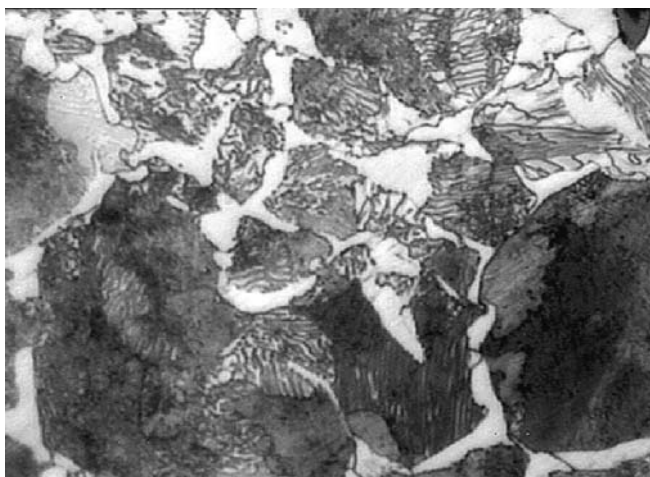
Figure 9. Micrographs taken from thread bottom S5 and thread crown S6 of power rotor material.
Slika 9. Mikrografi uzeti sa boka S5 i sa spoljnje površine S6 zavojnice materijala pogonskog vretena

Figure 9 shows a ferrite-pearlite microstructure of power rotor material on both specimens S5 and S6. The matrix is predominant pearlite and the structure is lamellar pearlite. Having in mind that cementite lamellas inside the pearlite matrix are not broken, it is possible to conclude with enough certainty that during operating lifetime, the power rotor did not reach temperatures at which cementite breaks or coagulation occurs. The minimum temperature of soft annealing or cementite lamella breakup and coagulation for steel S55C is 650°C . In spite that power rotor material S55C belongs to quenched and tempered group, a normalized microstructure of steels was found.
