**XX INTERNATIONAL CONFERENCE ON
"MATERIAL HANDLING, CONSTRUCTIONS
AND LOGISTICS"**

MHCL'12

Reparation of Steel Construction of Vehicle-mounted Self-propelled Crane's Telescopic Boom

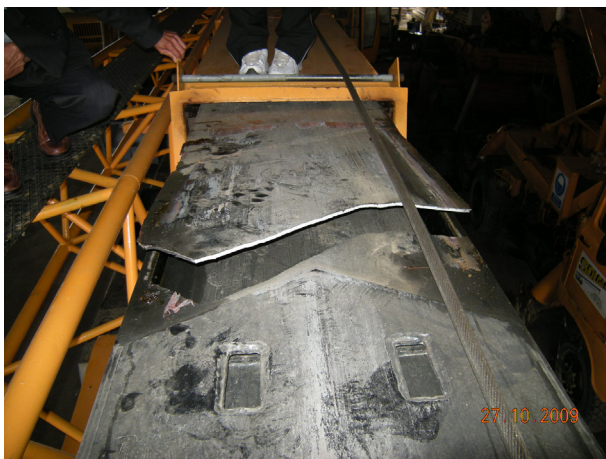
Figure 1 Crack of telescopic arm of vehicle-mounted crane

In order to determine the condition of damaged steel construction of boom, it is executed a preliminary visual inspection, and testing of welded joints and base material boom's segments. Preliminary visual inspection of the damaged segments indicated the presence of a large number of defects (discontinuities), cracks, fractures and deformities of the outer and inner surface of the steel structure segments in weld joints and base material. Some of them are shown in figures (Figure 1, Figure 2).

From the results of tests it was decided to carry out repairs to the observed cracks in welded joints and in the base material and the replacement of few sheets on segments, which were damaged during the exploitation. It was planned to install the reinforcement in some areas.

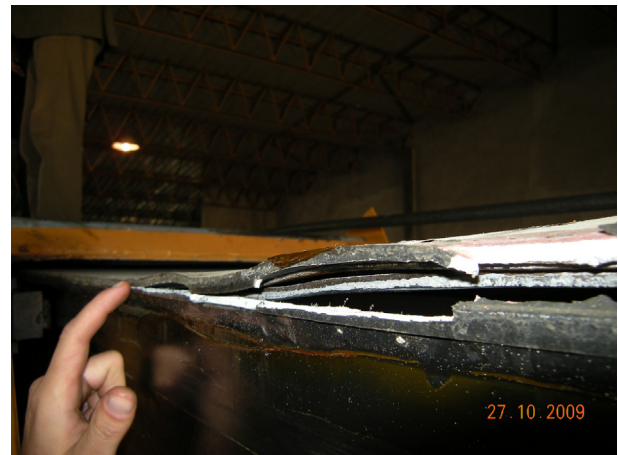
Figure 2 Deformation and cracks on steel construction of vehicle-mounted crane

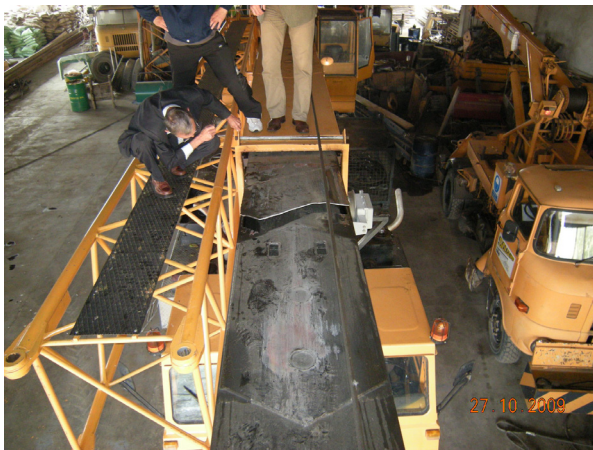
Before beginning of reparation it was done dismantling of boom onto five segments which were then placed in the bracket at horizontal position. Then it was performed cleaning procedure for all segments by sandblasting, to remove paint and prepare surface of base metal and welded joints for non-destructive testing (NDT). Welding surface (grooves) is formed by mechanical procedures (turning, grinding). The quality of prepared surfaces and tolerances of parts has been regulated by documentation of construction and technology in accordance with the SRPS C.T3.023 and SRPS C.T3.025 standards. Observed and marked cracks in welded joints and cracks in the base metal of segments are completely removed by grinding. In addition, wherever possible, tips of crack at the sheet plane (base material) were rounded by drill and irregularities (notches, sharp edges) were removed by grinding till metallic shine is achieved. Also, edges and roots of grooves are slightly rounded. All surfaces were cleaned of corrosion at the minimal width of 30 mm from the edge of the grooves with the metal wire brush till metallic shine is achieved. Greasy surfaces were cleaned by concentrated alcohol, trichloroethylene, at the minimal width of 50 mm from the edge of the groove. The time of preparation of the groove before welding should be as short as possible to reduce the possibility of subsequent contamination to a minimum. Figure 3 shows the preparation segments before reparation.

Figure 3: Segments preparation for auto crane repair

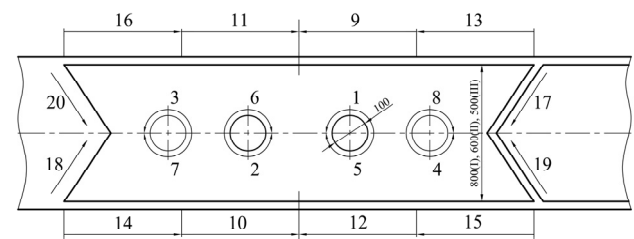
Figure 4: Welding plan of reinforcements in segments I, II and III (the numbers indicate the order of weld joints performing)

Connection of the sheet of segment No. 1 with the new sheet 1200 x 800 mm, and segment No. 3 with the new sheet 1200 x 500 mm are shown in the welding plan of reinforcements at segments I, II and III of the 95t crane (Figure 4), performed as a corner and butt joint. Before welding the sheet was preheated to approximately 150 0C and between two passes temperature was maintained in the range 210-220 0C, while the sheet was fastened to the plate by tacks 5-10 mm big at a distance of 150-200 mm from each other. After the welding was done, it was performed slow cooling to reduce stresses and the possibility of defects in welded joints. Tack welds are carried out under the same conditions as the root welds and it is required to be melted down or grinded. This requirement applies to all weld joints where the tack welds are present.

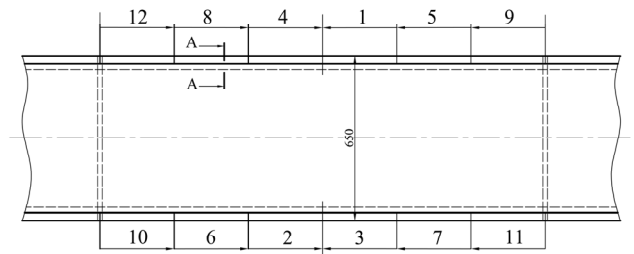
Figure 5: Welding plan of vertical sheets for lamella of segment II

Connection of the sheet of segment No. 2 with a new sheet with dimensions 1200 x 600 mm was carried out with the same parameters as the reinforcement of segment No. 1. Welding of these joints was performed with one or six passes from the medium to the ends with the weld length of 100-150 mm. The temperature between two passes was in the range of 210-220 0C. Continuation of the lamella of segment No. 2 is shown at the welding plan of vertical sheets for lamella of segment II (Figure 5) and is performed as a butt joint.

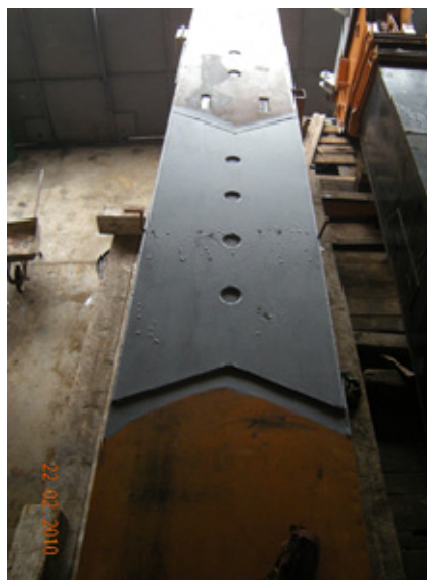
Figure 6: Appearance of steel construction of auto crane after repair

During the reparation, it was tended to apply procedures that minimize the occurrence of residual stress and strain, which are inevitable phenomena of reparation. Using welding technology it was successfully completed reparation of steel construction of boom of vehicle-mounted crane TADAHO TL 200 II /K. After the reparation (Figure 6) it was performed control of welded joints (visual, penetrant, and radiographic examination), and then it was assembled five segments of the boom and put into operation.
