Dejan Momčilović<sup>1</sup>, Nenad Hut<sup>1</sup>, Ljubica Milović<sup>2</sup>, Ivana Atanasovska<sup>3</sup>

## FAILURE ANALYSIS OF CHAIN BRACKET ANALIZA LOMA SPOJNICE LANCA

Original scientific paper  
UDC: 621.867.3.016 : 539.4  
Paper received: 10.07.2011

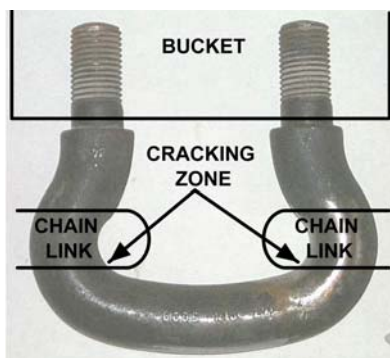
brackets, all unused chain brackets are tested by magnetic particle method. On several new chain brackets, cracks are found at the same zone as in-service brackets, Fig. 1. This has raised the question regarding the hidden production of flaws and the remedy for this type of cracks. These types of cracks are characteristic for one shipment only and another bracket shipment is replaced due to wear.

The contact zone between chain link and bracket, Fig. 1, is one of the most stressed zones in this elevator system,

Figure 1. Chain bracket with schematic connection of bucket with chain links.

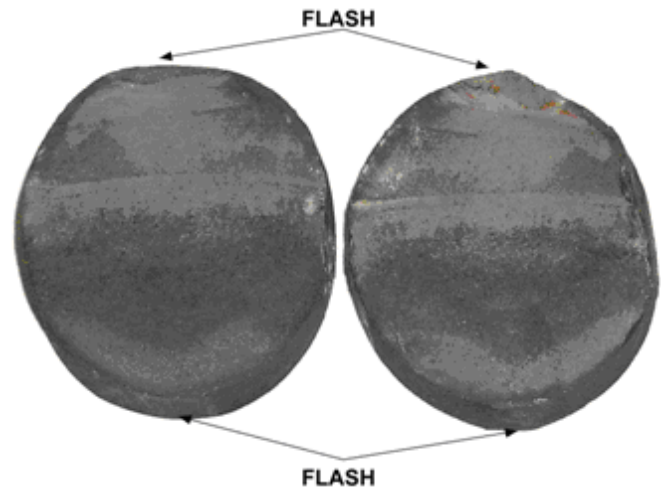
and in that zone fracture has occurred, Fig. 2. The fracture surface indicates that the bracket operated at the unidirectional bending at low nominal stress. The chain bracket is produced by forging with small flash line i.e. excess metal that extends out from the body of bracket. Sulphur print, Fig. 3 reveals that carburized depth is approximately 2 mm, in chain contact zone, with hardness profile shown in Fig. 4.

Figure 2. Fracture surfaces of chain bracket.

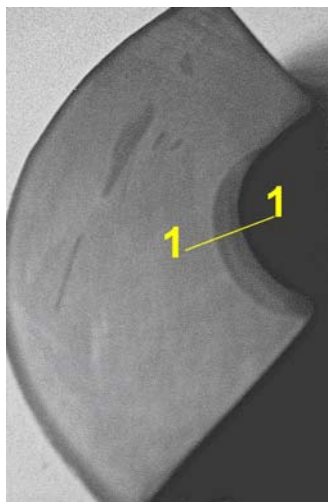
Figure 3. Carburized zone of chain bracket.

Chain bracket are produced from bars, hot bended before forging, which leads to wrinkling of material in zone 1-1, in Fig. 3. After cooling, small initial cracks, as a result of wrinkling, remain on surface. Subsequent forging, with distinct flash, and thermal cycles as a result of heat treatment only help propagation of those initial cracks. The storage of chain brackets during shipment disables moisture and oxidation. The environment where the chain bucket elevator is in-service is very dry, because cement is a highly hygroscopic material, so it is plausible to conclude that the oxide found in Fig. 8, is from production. The fact that operating stress is low combined to the high impact toughness of forging, has prevented the catastrophic failure of the chain bucket elevator.

The origin of cracks on new and in-service chain brackets is found in the production process, as a result of wrinkling of the material during hot bending. Simply a low-cost operation, after hot bending, the grinding in zone of further carburization could prevent the occurrence of cracks in chain brackets.

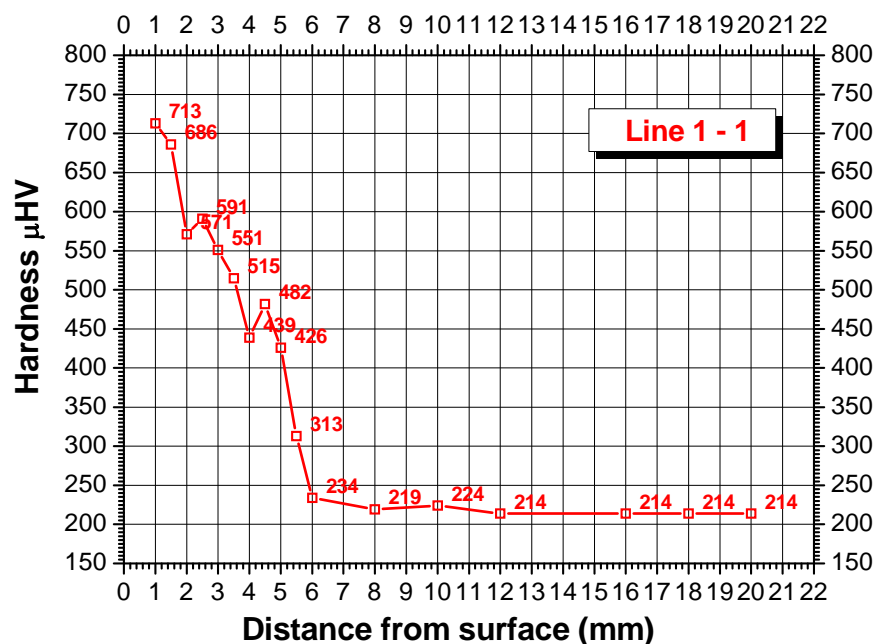
Figure 4. Hardness profile of carburized zone in Fig. 3.

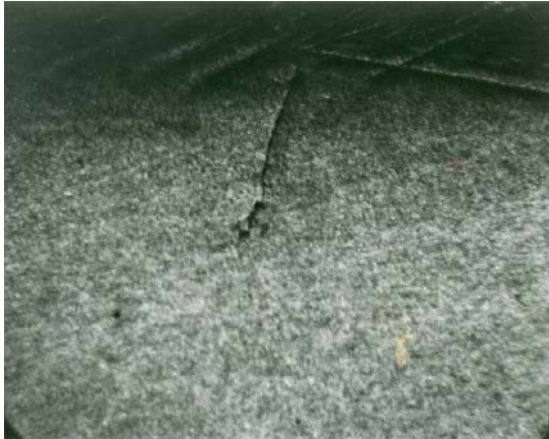
SEM analysis, from crack presented in Fig. 5, shows significant presence of oxide on crack surfaces, Fig. 8. Fatigue striations are shown in Fig. 9.

Figure 5. Carburized zone with the crack, hardness values between 600 and 700 HV.  
Slika 5. Cementirana zona sa prslinom, vrednosti tvrdoće između 600 i 700 HV

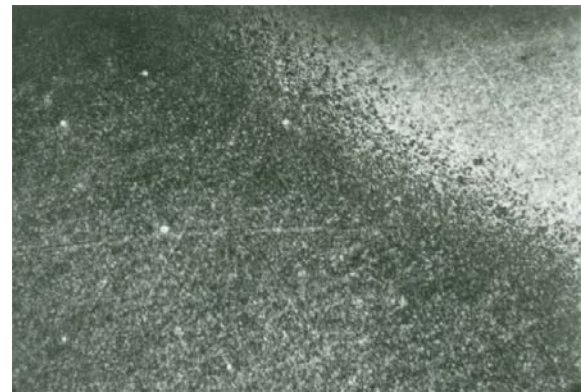
Figure 6. Transition zone, hardness values between 300 and 600 HV.  
Slika 6. Prelazna zona, vrednosti tvrdoće između 300 i 600 HV

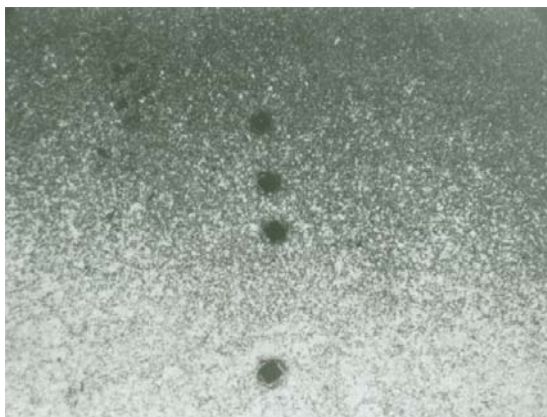
Figure 7. Fine grain ferrite-pearlite microstructure of chain bracket forging, average hardness value 220 HV.  
Slika 7. Finozrna feritno perlitna struktura otkovka spojnice lanca, prosečne tvrdoće 220 HV

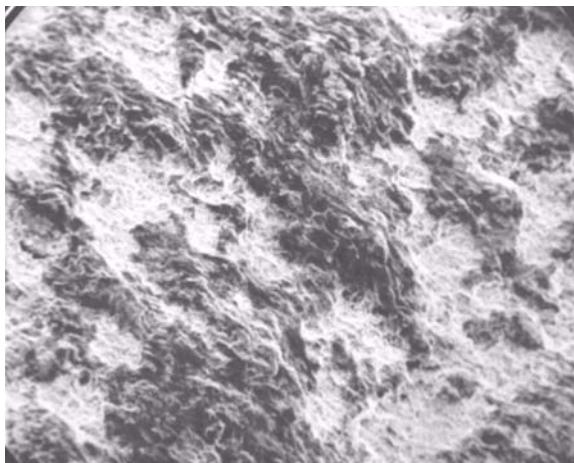
Figure 8. Oxide layer on fractured surface,  $\times 50$ .  
Slika 8. Oksidni sloj na prelomnoj površini,  $\times 50$

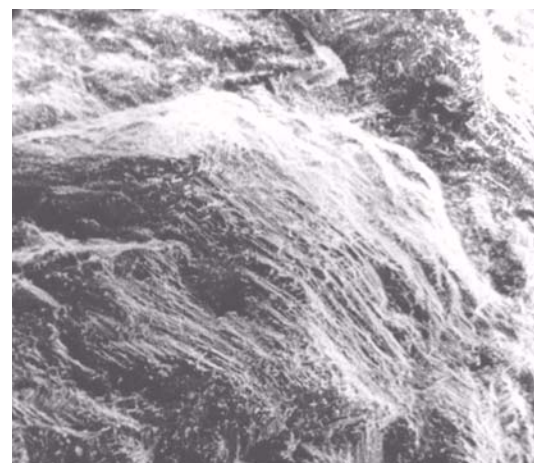
Figure 9. Fatigue striations on fractured surface,  $\times 5000$ .  
Slika 9. Linije zamaranja na prelomnoj površini,  $\times 5000$
