Economizer water-wall damages initiated by feedwater impurities

Sonja M. Vidojković¹, Antonije E. Onjia², Aleksandar B. Devečerski³, Nebojsa N. Grahovac³, Aleksandra B. Nastasović¹

PROFESSIONAL PAPER

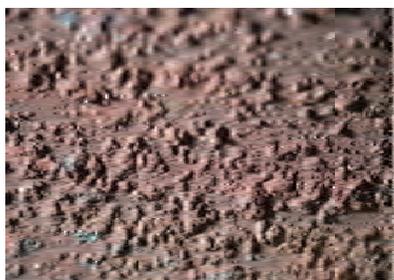
Six specimens were analyzed and results indicated that their internal surfaces are covered by scaled, scabrous, bulging and rugged deposit layer which is brown/reddish color. Metal surface was caved, crumpled and holey. A representative specimen is shown on Figure 1.

Figure 1. Internal surface of economizer.

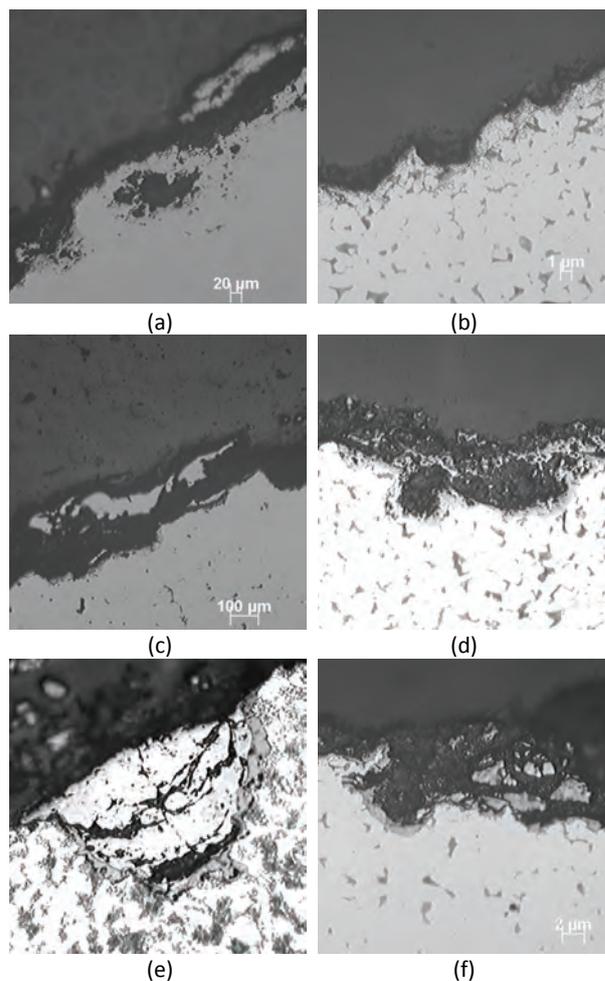
The microstructures of wall tube cross section for all specimens are presented on Figure 2. Distinctive feature of economizer's microstructure is presence of longitudinal cracks, approximately 50 μm length in material, which were propagated parallel to the tube surface (specimens 1 and 3). It pointed at the stress corrosion effect. Due to the presence of cracks in the tube wall further exposure to the same environment and strain will lead to the growth of cracks and rupture of tubes. Even very small concentrations of certain highly active chemicals, like chloride, have a huge contribution to the uprising the stress corrosion cracking and usually leading to devastating and unexpected failure. Corrosion pits (specimens 2, 4 and 6) that were rec-

Figure 2. Cross-sectional view of specimens: a) specimen 1 with stress corrosion cracking, b) specimen 2 with corrosion pits, c) specimen 3 with stress corrosion, d) specimen 4 with corrosion pits, e) specimen 5 with cracks in oxide layer and f) specimen 6 with corrosion pits.

orded on microphotographs, clearly indicated that pitting corrosion took place in all specimens. Pitting corrosion could be attributed to the oxygen attack to the metal substrate. Microstructure analysis evinced destruction of the protective layer (specimen 5) that led to development of nonprotective scale localized on the internal tube surface. The precipitation of magnetite scale can increase the tube metal temperature and cause cracks and other deformations of metal construction [14–16]. Thickness of deposit layer varied between 13 and 160 μm . Whereas analysis revealed excess of chloride in feedwater, one of possible explanations of developing nonprotective magnetite can be based on the mechanism of local formation of acid chlorides. Result of this process is pH drop, due to creating an acidic region with a high Cl^- concentration. Hydrolysable chlorides cause degradation in these zones of the protective film. The most likely cause of increased concentration of chloride in feedwater is hydrochloric acid (HCl)

utilized for regeneration of the ion exchange resins in condensate polisher. Consequently, the chloride concentration can be diminished by proper regeneration of polishing and water treatment plants and their accurate exploitation. Introducing of continuous on-line and daily laboratory monitoring of chloride in demi and feedwater by ion chromatography technique are also important measures for maintaining chloride below specified target values. Aside from that, the attention should be paid to the control and cease of condenser leakage that can be an additional source of chloride in feedwater. On the basis of obtain microphotographs, material microstructure was unmodified and consisted of ferrites and perlites.

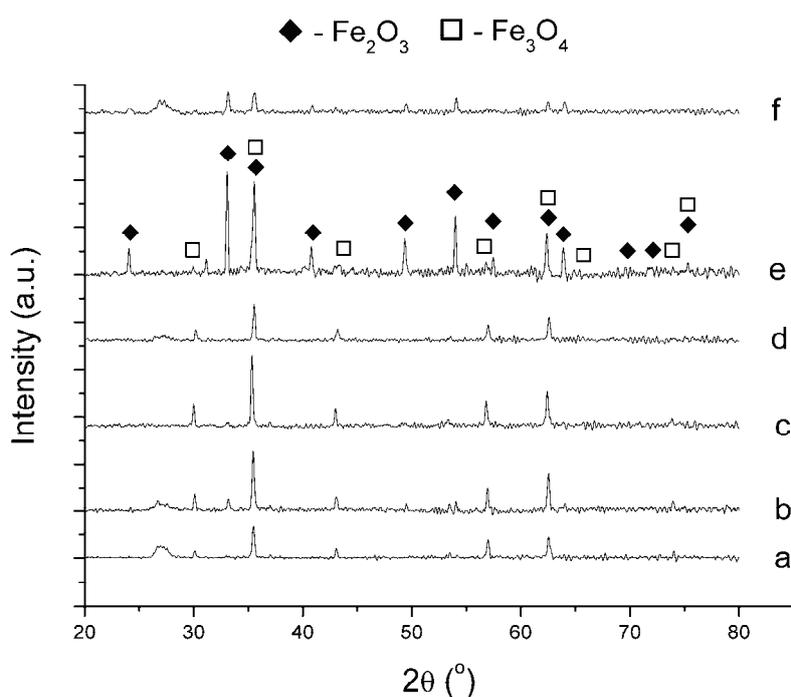
Structural characterization of deposit was made using X-ray diffraction (XRD). The main constituents of deposit from specimens 1, 2, 3, 4, 5 and 6 have confirmed to be magnetite (Fe_3O_4) and hematite (Fe_2O_3) (Figure 3). The deposit layer composition of specimens 5 and 6 consists of magnetite and prevalent amount of hematite. Iron oxides are typical steel oxidation products (9,14,17–19). However, the presence of hematite may indicate irregularity in the power cycle operation and high corrosion rate. Moreover, hematite does not provide corrosion protection and has lower electrical and thermal conductivity than magnetite. Hematite also might be carried over to the boiler tubes from other part of the system. Though magnetite is protec-

tive corrosion product, in present case its porous and brittle nature might have an adverse effect on the protection of the boiler tube surface. Porous magnetite rust can enhance the corrosion at the tube surface by acting as an active cathodic site and deploy under-deposited corrosion [20].

Figure 3. Diffractogram of specimens: a) 1, b) 2, c) 3, d) 4, e) 5 and f) 6.
