Case Report

An Extremely Rare Case of Cementless Third Generation Corail Stem Neck Fracture With Fractographic Analysis

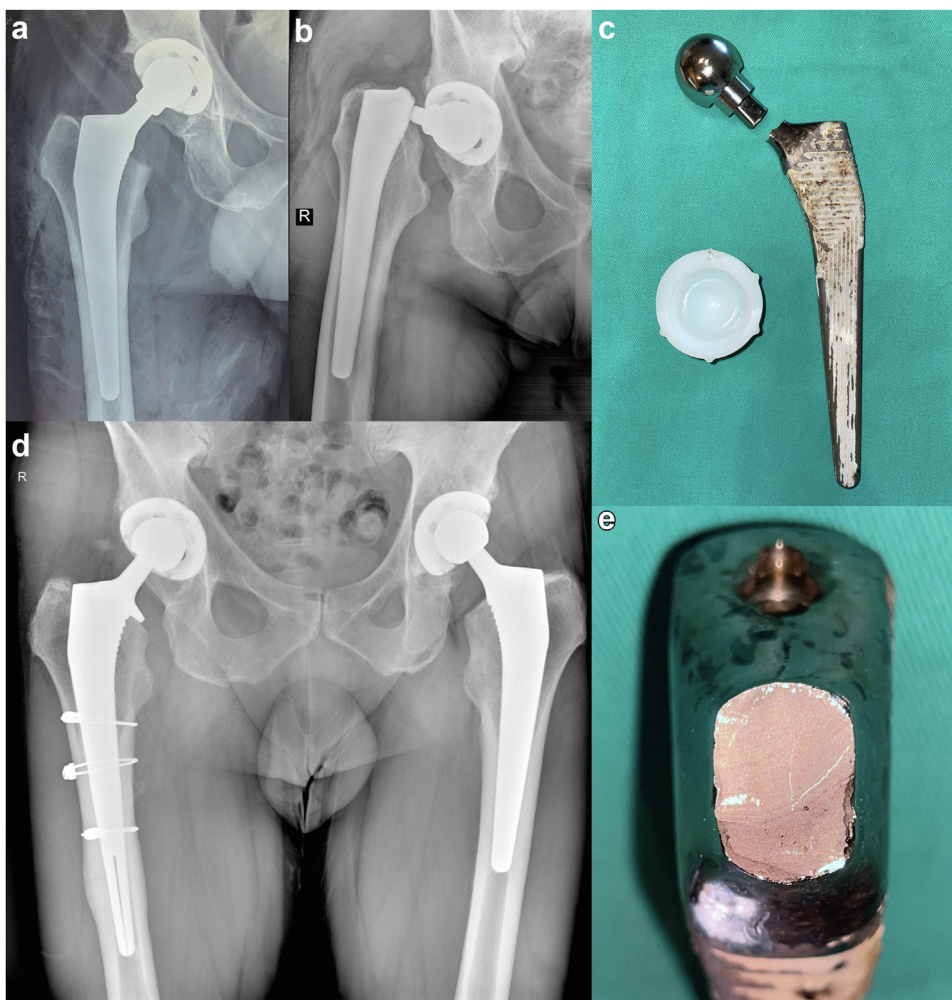
A 66-year-old patient came to our emergency room due to the sharp pain in his right hip that occurred suddenly when standing up from a chair. He underwent total arthroplasty of the right hip 6 years ago (Fig. 1a) and the left hip 4 years ago due to osteoarthritis, followed by full recovery. He is an office worker with no relevant and apparent traumatic events.

The physical examination revealed a completely healed surgical scar, moderate pain in the right groin, with shortening and external rotation of the right leg. Radiographs taken at that time showed a broken stem in neck region with transverse pattern (Fig. 1b).

Figure 1. (a) Anteroposterior radiography showing preinjury right hip arthroplasty; (b) transverse neck fracture; (c) position of the fracture on the neck of the extracted hip prosthesis; (d) 8-month postoperative radiograph; (e) photograph of the fracture surface on the stem side.

articular hematoma was found, along with the mentioned fracture of the stem neck with consequent marginal damage to the polyethylene liner. The acetabular and femoral components were firmly fixed to the bone and adequately oriented. No signs of periprosthetic infection, metallosis, or wear of the polyethylene liner were found. The stem was removed through a transfemoral approach with an extended trochanteric osteotomy. The bony femoral flap was secured using 3 cerclage cables (Zimmer-Biomet, Warsaw, IN). A Corail revision stem size 18 (De Puy, Synthes, Warsaw, IN) was implanted. A new polyethylene liner Pinnacle (De Puy, Synthes, Warsaw, IN) size 56 mm with 10 degrees of inclination was placed. A new CoCr +9/32 mm femoral head (De Puy, Synthes, Warsaw, IN) was used (Fig. 1d).

Figure 1c shows the failed hip prosthesis and the position of the fracture. A macroscopic overview of the fracture surface, shown in Figure 1e, reveals 2 distinct regions: the region covered with curved lines that occupy most of the fracture surface and the region with a granular appearance. In SEM images at low magnifications, shown in Figure 2a, 3 zones are distinguished. Curved lines that spread radially through the central zone of the fracture surface (marked as zone 2) are the traces of the fatigue crack propagation, known as beach marks. Beach marks are considered a clear indication of the fatigue fracture type. The curvature of the beach marks points back to the area of the fracture initiation placed at the edge of the

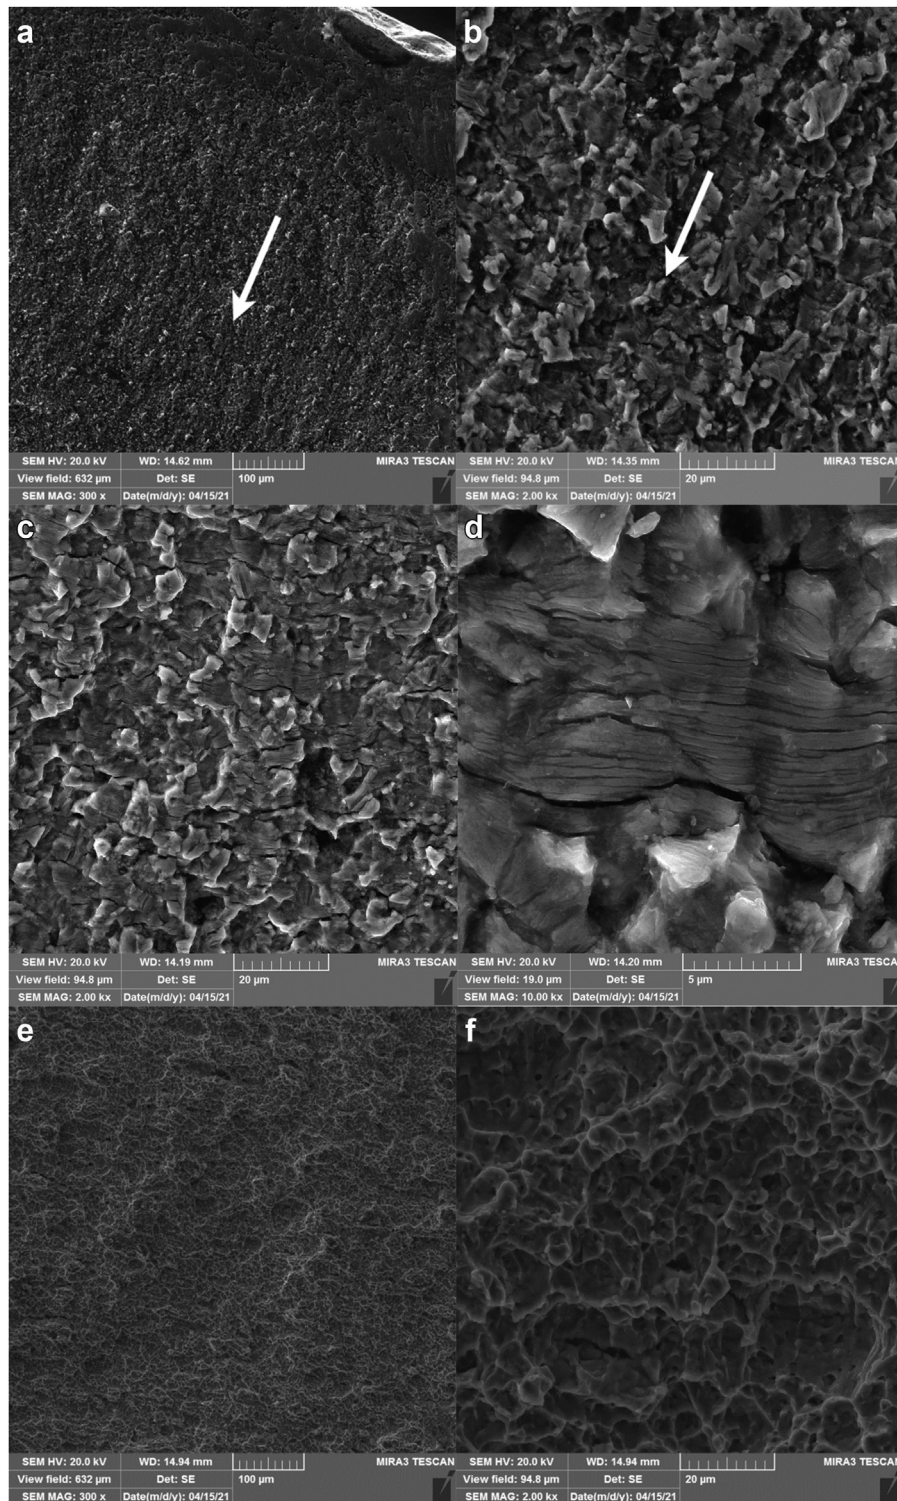
Figure 3. Fracture surface in the vicinity of the crack origin on the neck side: (a) granular structure of the fracture surface; (b) very fine fatigue striations and secondary microcracks. Fracture surface near the crack origin on the stem side: (c) irregular fatigue striations and many secondary microcracks; (d) fatigue striations and secondary microcracks alongside intergranular secondary microcracks. The zone of the final fracture: (e) overview of the fracture surface; (f) ductile dimples in the zone of the final fracture.

Figure 3 displays SEM micrographs of the fracture surface in the zone of fatigue crack propagation (zone 2) in early stages, near the fracture origin (up to the right in Fig. 3a). The arrow in the pictures in Figure 3a and b indicates the direction of the fatigue crack propagation front. The fracture surface in this zone is coarse, granular, and contains many irregular voids. Fatigue striations are barely visible at the magnification of the micrograph in Figure 3b. At even higher magnification in Figure 3c, striations become observable. Striations are the microscopic traces of the fatigue crack propagation through the mechanism of opening and closing of the crack, and therefore they serve as the confirmation of the failure by fatigue fracture. Besides fine fatigue striations, there are many deep secondary cracks perpendicular to the fatigue fracture surface (Fig. 3c). Secondary cracks may indicate the brittleness of the material [8]. Irregular and wavy striation lines in SEM micrograph in Figure 3d were formed by changing the plane of propagation upon encountering the obstacles in structure [8]. Grains between fatigue striations look smooth, but at higher magnifications, it can be observed that the striations in those parts are actually less pronounced and barely observable (Fig. 3d, lower part of the image).

The fracture surface in the third zone (zone 3 in Fig. 2a) is characteristic of the final rupture stage of the fatigue fracture. Ductile dimples at the fracture surface, visible in SEM images in Figure 3e, indicate the ductile type of the final fracture. Higher magnification reveals an equiaxed shape of ductile dimples (Fig. 3f), which indicate tensile stress acting perpendicularly to the fracture surface [8]. Therefore, the final fracture was due to the overload of the remaining cross-section area under the influence of tensile stress.
