INTEGRITY AND RISK ASSESSMENT OF RECONSTRUCTED STEAM LINE PROCENA INTEGRITETA I RIZIKA REKONSTRUISANOG PAROVODA

FACILITY DESCRIPTION

DAMAGES ON STEAM LINE

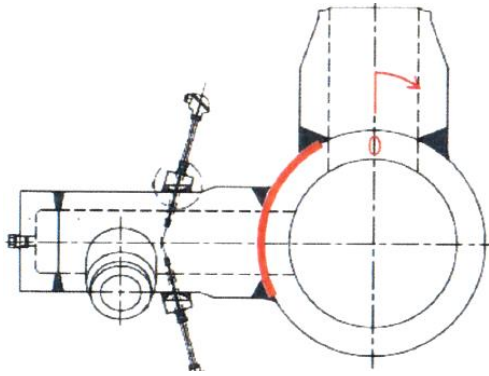
Extensive assembly work during reconstruction of the RA line was preceded by an ever more extensive process of prefabricating steam line parts in workshop conditions. During the final non-destructive tests of the fresh steam RA line, it was determined that one of the welded joints does not fully meet the quality requirements. Volumetric and surface indications detected in the material were still within acceptable limits, but it was also determined that hardness values in the welded joint and parent material of 1RA30-B24 collector, in the vicinity of pipes and lids, were below acceptable level. Figure 1 shows the location of the region where measured hardness values were below minimal values according to the relevant standard.

Figure 1. 1RA30-B24 collector, with a detailed view of the region with measured hardness levels below the allowed minimum.

The region marked in red in Fig. 1 depicts hardness values in the parent material from 120 to 160 HB, whereas values in the weld metal were slightly higher, 150-170 HB.

In order to meet the quality requirements for steam line welded joints, it was necessary to reconstruct the collector. Thus, there was a need to remove the region with the detected insufficiently hard material. Next, a new lid was to be manufactured and installed.

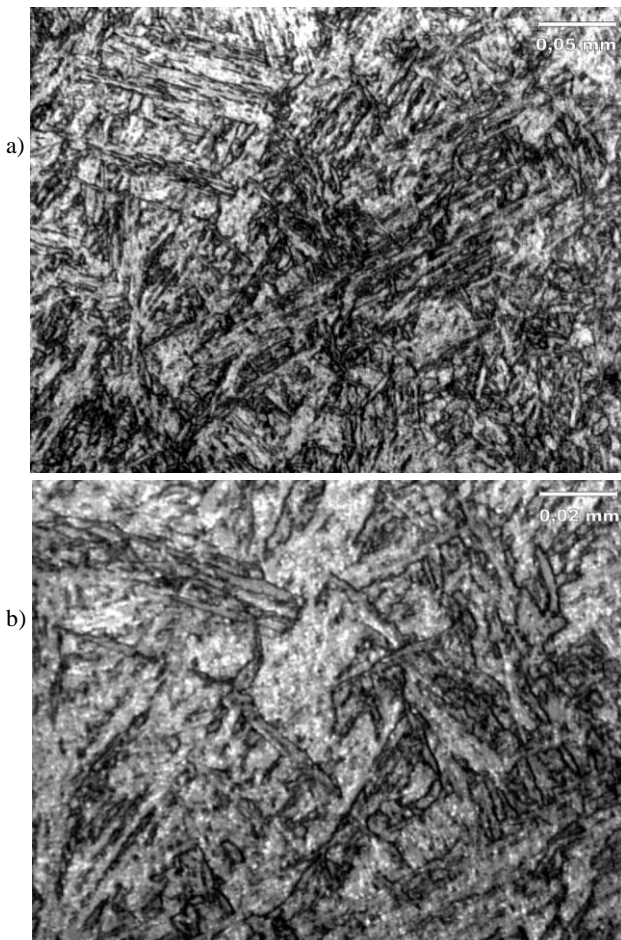
Figure 2. Microstructure of X10CrMoVNb9-1 (219 HB), magn. 200 \times (a), and 500 \times (b), showing the region with satisfactory microstructure.

The steel X10CrMoVNb9-1 microstructure is shown in Fig. 2, as the result of replica method used on a part of the parent material that was not damaged, with 200 \times and 500 \times magnification. It can be concluded from this replica analysis that tempered martensite is present in the microstructure which corresponds to the expected state of the material. Such structure is also present in the areas with no detected damage.

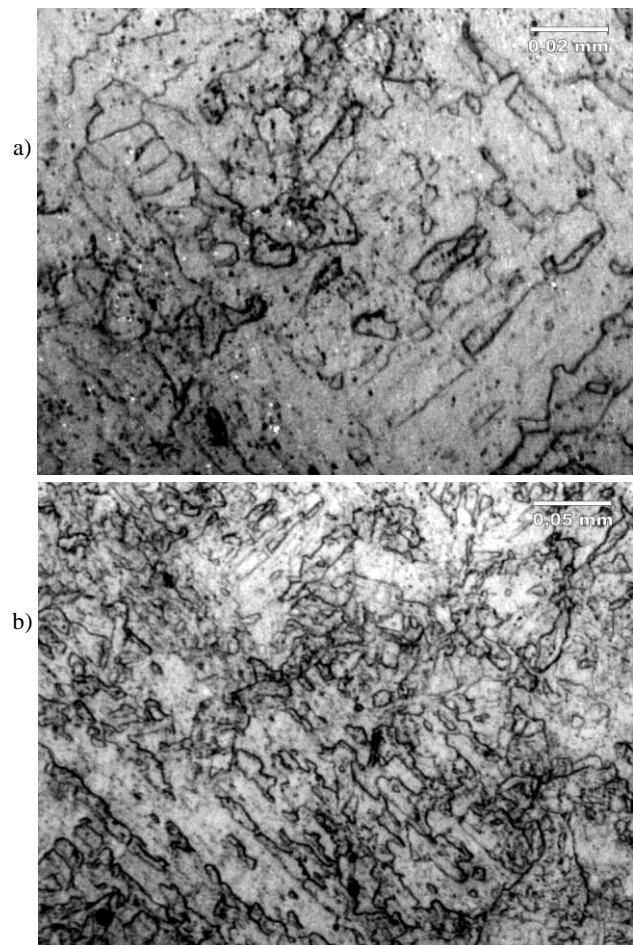
In addition, the region with lower than expected hardness values for steel X10CrMoVNb9-1 were obtained using the replica method (Fig. 3), with 200 \times and 500 \times magnification. After performing replica analysis it was determined that the weld metal microstructure underwent significant transformation. Due to this, ferrite was dominant in the microstructure in the form of a carbide mix, whereas tempered martensite, typically encountered in this material, appeared only in traces. All this points towards preheating of the material during the heat treatment.

Figure 3. Microstructure of X10CrMoVNb9-1 (143 HB) at the collector pipe, magn. 200 \times (a), and 500 \times (b), material with unsatisfactory microstructure.

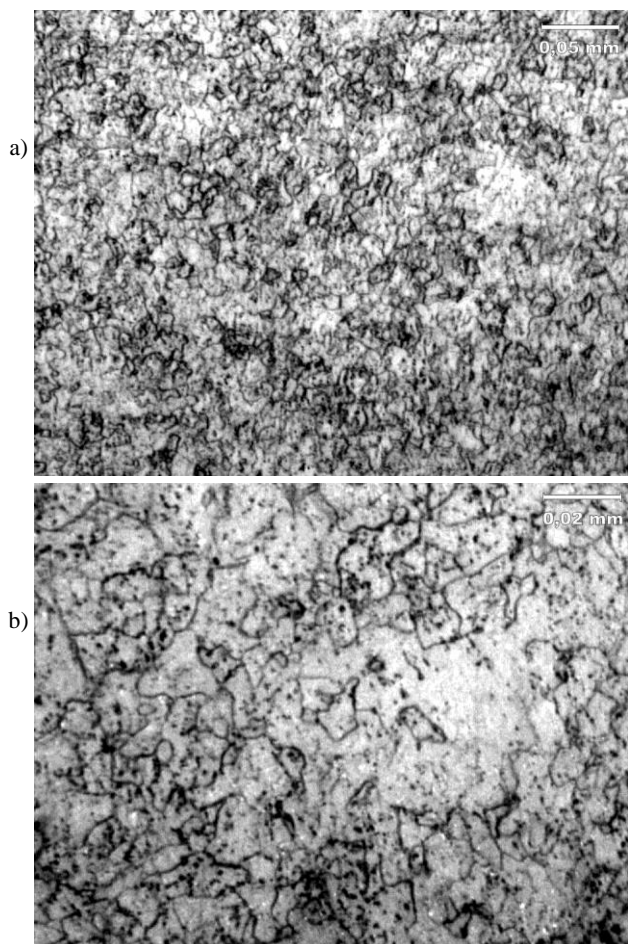
Collector lid material in the immediate vicinity of the welded joint underwent microstructural changes, along with pipe material, Fig. 4. Ferritic microstructure was dominant again in the form of carbide mix, whereas tempered martensite was almost entirely absent.

Considering that the replica method confirmed hardness results that were below the minimal level in certain regions,

it was determined that material degradation was indeed caused by preheating during post-weld heat treatment.

Figure 4. Microstructure of X10CrMoVNb9-1 (142 HB) of the collector lid, magn. 200× (a), and 500× (b), material with unsatisfactory microstructure.

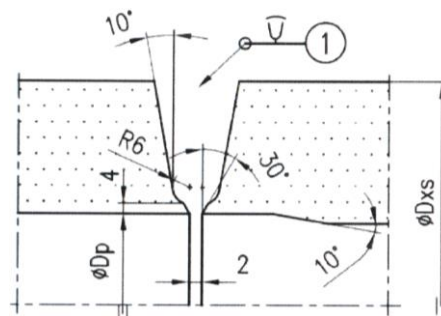
Figure 5. Groove geometry and fill plan for a circular welded joint between collector lid and pipe; material - X10CrMoVNb9-1.

Hence, particular attention needs to be devoted to proper selection of the welding process. Figure 5 shows the groove geometry at pipe and collector lid connection, using X10CrMoVNb9-1 as parent material along with groove fill plan.

The required welded joint quality level can be achieved via appropriate preheating at temperatures ≥ 220 °C, wherein welded joints are subjected to stress annealing at 740 °C after welding, with a total duration of 180 min. This heat treatment process is performed in order to remove residual stresses that occurred during martensitic transformation, thus producing a tempered martensite structure.

Welded joints were made using a combination of TIG and MAW processes. The root pass was done using TIG, with C9 MV-IG filler material manufactured by Böhler, /11/, with 100 % Ar as shielding gas. Fill passes were done using MAW, with a coated electrode FOX C9 MV, also manufactured by Böhler, /11/. This electrode was previously dried at 300 °C for 2.5 h.

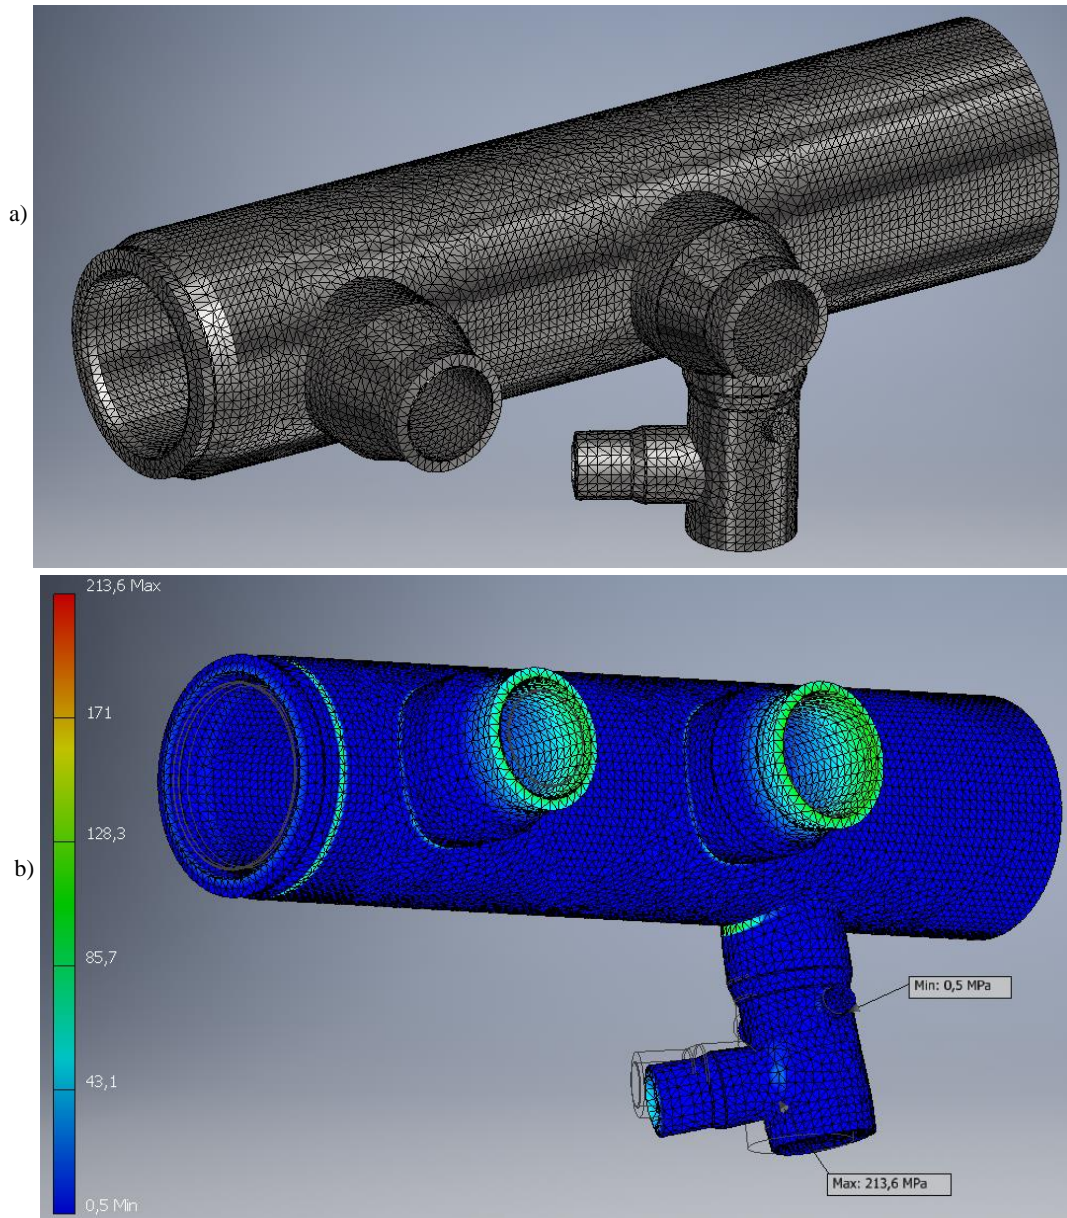
Numerical simulation of the stress state was made to provide additional confirmation of collector integrity, using static pressure of $p = 20.6$ MPa. The stress state and the finite element mesh for the RA collector model are shown in Fig. 6, indicating maximum value $\sigma_{max} = 213.6$ MPa.

Figure 6. Finite element modelling: a) finite element mesh; b) stress state in the collector.

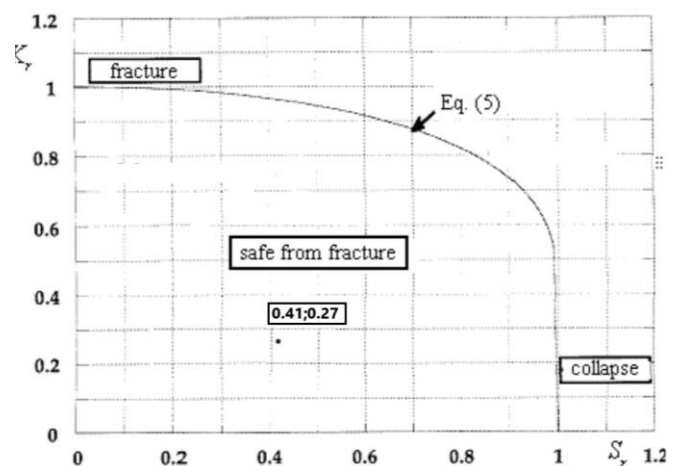
The coordinates of the point in the FAD (0.41; 0.27) are in the safe area, Fig. 5, at the level of fracture probability, approximately 0.42.

Figure 5. Failure analysis diagram for 1 mm long crack.

Risk level is determined according to the consequence, which is evaluated as highest due to possible damage and fatalities, and probability (medium). Risk matrix can now be obtained in a simple way, as shown in Table 3, indicating high level of risk.
