Ljubica Milović, Milorad Zrilić

FAILURE ANALYSIS OF ROTARY SCREW PUMP ANALIZA HAVARIJE ROTACIONE VIJČANE PUMPE

Stručni rad / Professional paper
UDK /UDC: 621.66-75
Rad primljen / Paper received: 27.09.2008.

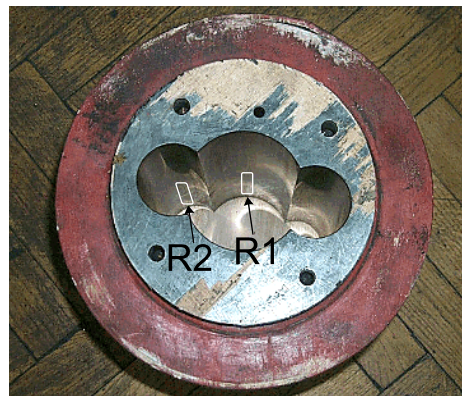
Figure 2. Positions of replication on casing inner surface.
Slika 2. Mesta uzimanja replika na unutrašnjoj površini kućišta

Replicas for metallographic analysis on casing inner surfaces were taken at locations R1 of power rotor rest and R2 of idle rotor rest, as presented in Fig. 2, /1/.

The examination of replica R2, taken in position of detected damage, revealed local deterioration as craters on very fine prepared surface, Figs. 4 and 5. The material is partially torn, i.e. small particles and pieces of casing material fell out. Weak bonds on metallic grain boundaries are most likely the cause, and may be the consequence of some

Revealed surface damages of the tearing type at typical locations of casing inner surface indicate that some deviation from normal operating regime of pump rotary parts

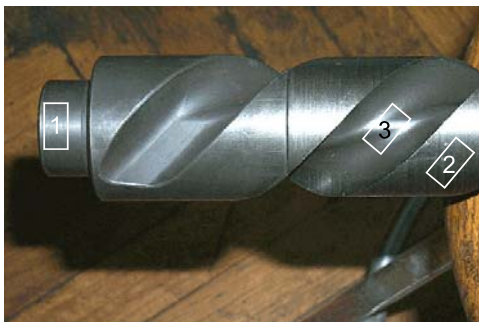
Figure 6. Sample positions on idle rotor.
Slika 6. Uzorci sa slobodnog vretena

Three samples (Fig. 6) were taken from idle rotor – S1 at rotor end, S2 thread crown, and S3 at thread bottom. Same samples (Fig. 7) were taken from power rotor, S4 (not visible in Fig. 7), S5 and S6, respectively. Micrographs S2 and S3 of idle rotor material are shown in Fig. 8, and S5 and S6 of power rotor material in Fig. 9.

Figure 8 shows typical gray iron structure with presence of graphite eutectic containing silicon on specimens S2 and S3. The eutectic grows as cellular with fine graphite eutectic indicating higher cooling rate of casts. No differences in microstructure that can show eventual overheating of the material caused by friction and abrasion during the accident were noticed among tested positions of idle rotor.

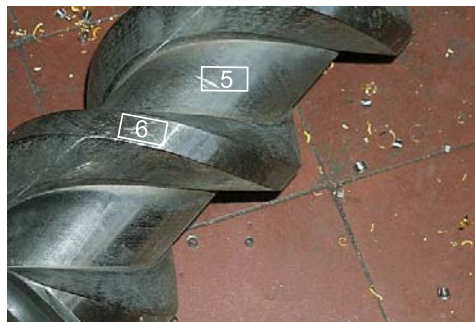
Figure 7. Sample positions on main screw (sample 4 is on rotor end).
Slika 7. Uzorci sa pogonskog vretena (uzorak 4 je na kraju vretena)

Figure 9 shows a ferrite-pearlite microstructure of power rotor material on both specimens S5 and S6. The matrix is predominant pearlite and the structure is lamellar pearlite. Having in mind that cementite lamellas inside the pearlite matrix are not broken, it is possible to conclude with enough certainty that during operating lifetime, the power rotor did not reach temperatures at which cementite breaks or coagulation occurs. The minimum temperature of soft annealing or cementite lamella breakup and coagulation for steel S55C is 650°C . In spite that power rotor material S55C belongs to quenched and tempered group, a normalized microstructure of steels was found.

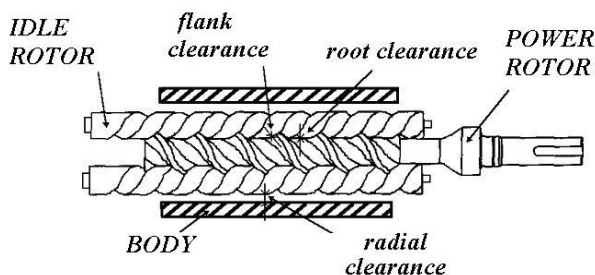
Figure 10. Running clearances of rotary pump elements, /1/.
Slika 10. Radni zazor elementa rotacione pumpe, /1/

occurred. Torn material particles had entered the oil stream flow and produced wear on all three gapping surfaces (between casing and rotors, at the bottom and on flank surfaces between power and idle rotors), thus producing a pressure decrease on the pump outlet.

Clearance regions of rotary pumps are the most susceptible to damage and abrasion from solids, contaminants, and foreign material. Running clearances are those spaces between stationary and rotating parts and between adjacent rotating pump components, Fig. 10; in a pump they can range from less than 0.025 mm to about 0.254 mm depending on pump size and pressure rating. Internal slip flow (volumetric inefficiency) carries the liquid born debris towards pump running clearances. This debris can cause jams or pits on pumping elements, scoring of clearance surfaces and abrasive erosion of clearance components. Jamming or breakage is catastrophic in nature and can cause immediate system shutdown with its attendant outage costs, as well as extensive repair time and cost. Scoring and abrasion of clearance surfaces will usually reduce the pump output flow by allowing increased slip through increased clearances. This is usually detected as a loss in system discharge pressure, due to the loss of pump flow rate.
