## The morphology of cavitation damage of heat-treated medium carbon steel

*Abstract:* In this paper the morphology of the cavitation damage to heat-treated medium carbon steel was analyzed. The experiments were conducted using a modified vibratory cavitation test set up. The erosion rates were measured by an analytical method. The morphology of the cavitation damage was studied by the scanning electron microscopy and optical microscopy techniques. The present work was aimed at understanding the cavitation erosion behaviour of heat-treated medium carbon steel under laboratory conditions. The results indicate that the heat-treated medium carbon steel is not to be recommended for the production of hydraulic machinery parts exposed to high hydrodynamic intensity.

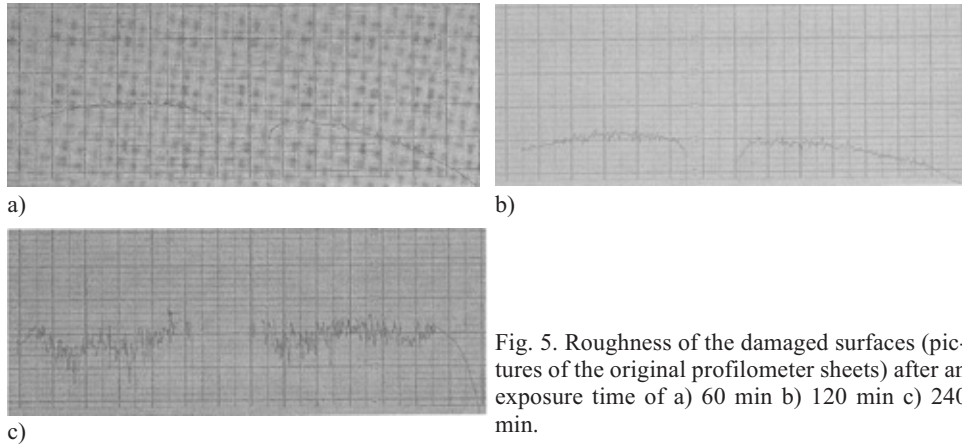
The roughness of the damaged surfaces of the specimens, obtained by the profilometer, are shown in Fig. 5a, b and c for test durations of 60, 120 and 240 min, respectively.

Fig. 5. Roughness of the damaged surfaces (pictures of the original profilometer sheets) after an exposure time of a) 60 min b) 120 min c) 240 min.

The value of roughness, in the first stage of cavitation damage after 60 min was  $R_a = 0.455$   $\mu\text{m}$  (Fig. 5a). The low roughness is the result of the long incubation period (30 min), and it indicates that little surface damage occurred during this period. Increasing the exposure time results in greater cavitation damage of the surface and the value of the roughness after 240 min was  $R_a = 2.25$   $\mu\text{m}$  (Fig. 5c). Such a high value of roughness can be explained by the separation of massive particles from the damaged surface.

Fig. 6a shows a SEM micrograph of the surface during the first stage of cavitation damage, *i.e.*, after 60 min. The start of cavitation attack over grain boundaries and surface of grains can be clearly seen. Surface undulations indicate that there is deformation of the grains. This is in accordance with the roughness obtained in this stage of cavitation damage, shown in Fig. 5a. Metal loss was already recorded, but the erosion was mostly confined to the individual areas.

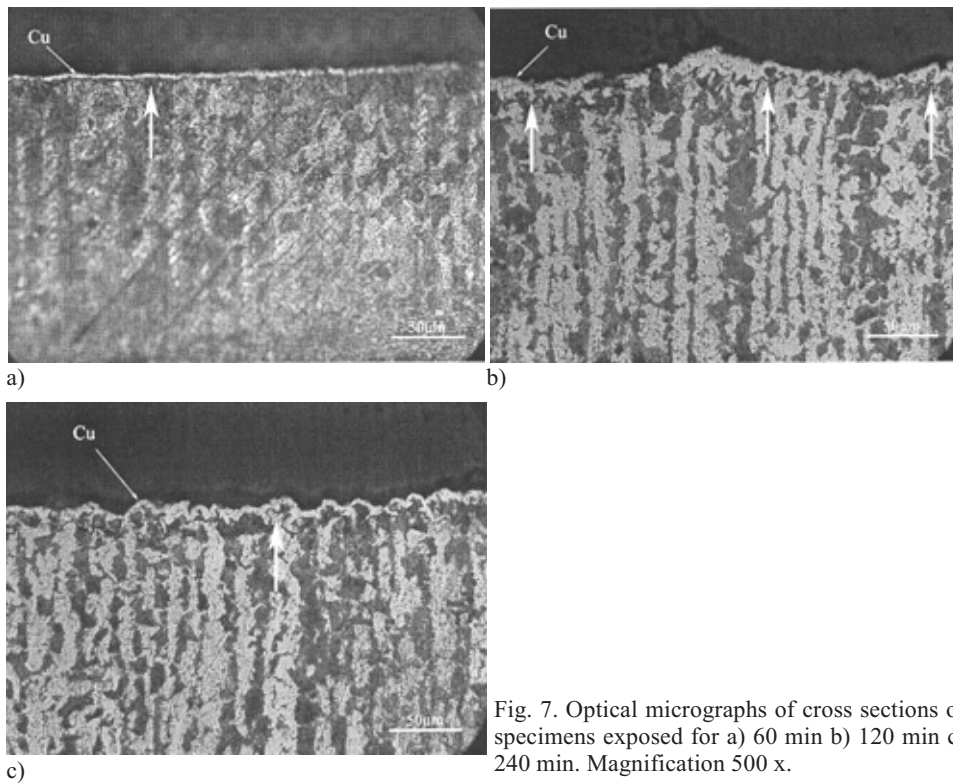
Optical micrographs of the cross sections of the test specimens after cavitation testing, for 60, 120 and 240 min are shown in Fig. 7 a–c, respectively.

Fig. 7. Optical micrographs of cross sections of specimens exposed for a) 60 min b) 120 min c) 240 min. Magnification 500 x.

An optical micrograph of the cross section of the test specimen in the first stage of cavitation damage, *i.e.*, after 60 min, is shown in Fig. 7a. Surface undulations and plastic deformation of the surface layer can be seen (marked with arrow).

An optical micrograph of the cross section of a test specimen after 120 min of cavitation action is presented in Fig. 7b. In the plastically deformed layer covered with numerous small pits, cracks nucleate and develop. The cracks, marked with arrows, follow the boundaries of deformed and non-deformed grains.

According to the optical micrograph in Fig. 7c, there are many places where metal particles had been removed. Also, in the subsurface layer of the test specimen the cracks may be seen. These cracks can link, leading to separation of metal particles from the test specimen. A particle which was about to be separated is indicated by an arrow in Fig. 7c.
