SUITABILITY OF HEAT TREATMENT FOR CRACK RESISTANCE OF MATERIAL IN THE CONNECTION PART OF HEAVY TRANSPORTER FOR LIQUID SLAG

The post weld heat treatment (PWHT) was used to reduce the level of the residual stresses and increase of the crack resistance of the material in the connection part. The article presents the results of the residual stress measurements immediately after welding and after the stress relaxation by the PWHT.

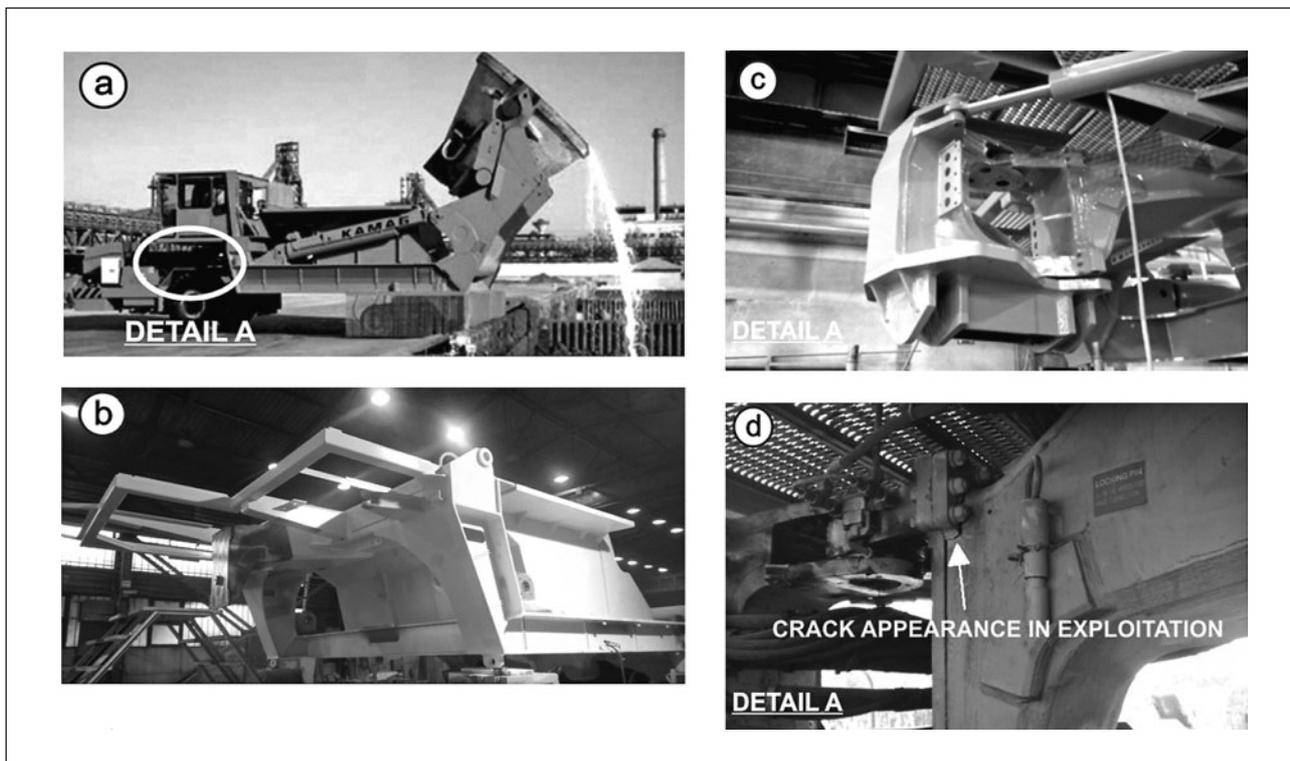
Figure 1 Mobile transporter for slag: a) transporter and detail A where is connection part of the hinge joint located, b) rear part of the transporter, c) connection part and the hinge joint, d) crack in the connection part of the hinge joint in exploitation

increased [2]. The method is appropriate for low alloy construction steels, but more problems occur with its use at micro-alloyed and HSLA steels due to precipitation of carbides. This article deals with RSs measurements on the connection part of the hinge joint of the mobile transporter's construction for transport of liquid slag. It's construction weights 120 tons and can carry 90 tons of liquid slag. During exploitation on the connection part of the transporter crack initiated and propagate until transporter need to be serviced. Figure 1 shows the mobile transporter for liquid slag, the rear part of the transporter and location where crack appeared in exploitation (detail A).

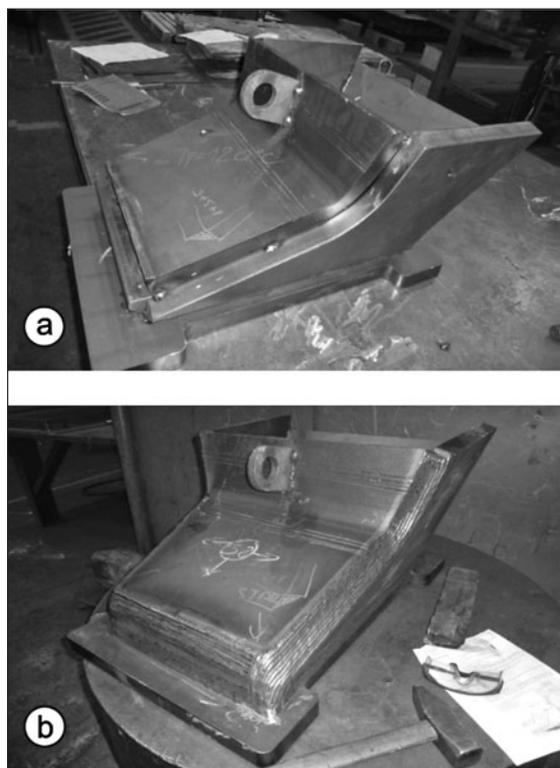
Figure 2 The connection part of the transporter's construction during manufacturing, a) before welding, b) after welding

The connection part during manufacturing by welding is presented in Figure 2.

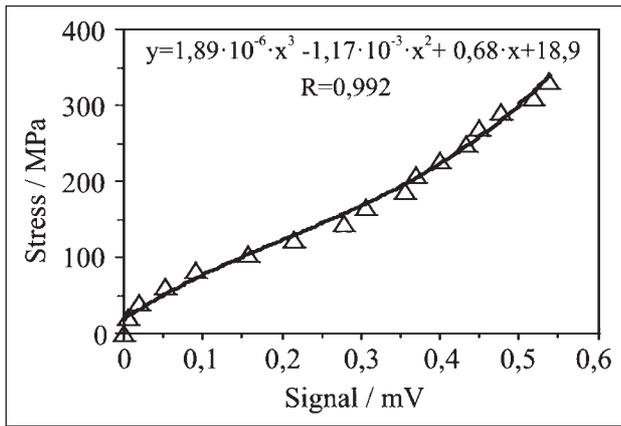
Figure 3 The calibration curve

Post weld heat treatment was performed in the furnace. The heating speed was 140 °C/h. The connection part was held for 2 h at temperature of 590 °C and then it was cool down in the furnace. The cooling speed was 100 °C/h. When the connection part reached 200 °C, it was cooled down in the air. Vickers Hardness HV10 were measured in the in the weld joint in the vicinity where crack initiate and propagate in exploitation in the connection part of the hinge joint. Hardness were measured in “as welded” condition and post weld heat treated condition (“PWHT”) as well. Three different magnetic methods exist for measuring of RSs [1]. The first is Induced Magnetic Anisotropy Method, the second is Berkhausen Emissions Method and the last is Magnetic Acoustic Emission Method [7]. The Induced Magnetic Anisotropy Method is used for the experimental measurements. We have measured the difference between principal RSs and their direction. The calibration of the method was necessary to be performed on the same material before measurements. For this purpose the flat tensile specimen (40×20 mm) was machined from steel S355 J2. The calibration curve is shown in Figure 3.

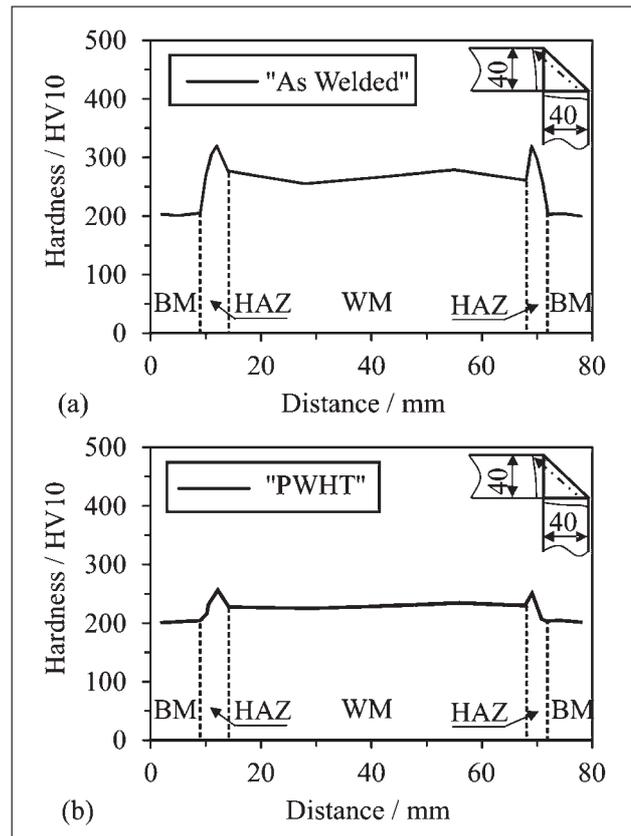
Figure 4 Results of hardness measurements; a) "As welded" condition, b) "PWHT" conditions

Results of hardness measurement HV10 are shown in Figure 4. Hardness were measured in weld metal - WM, heat affected zone - HAZ and base material - BM. Figure 4a shows results in "As welded" condition and Figure 4b shows results in "PWHT" condition. Measurements were performed in weld joint in the vicinity where crack appeared in exploitation.

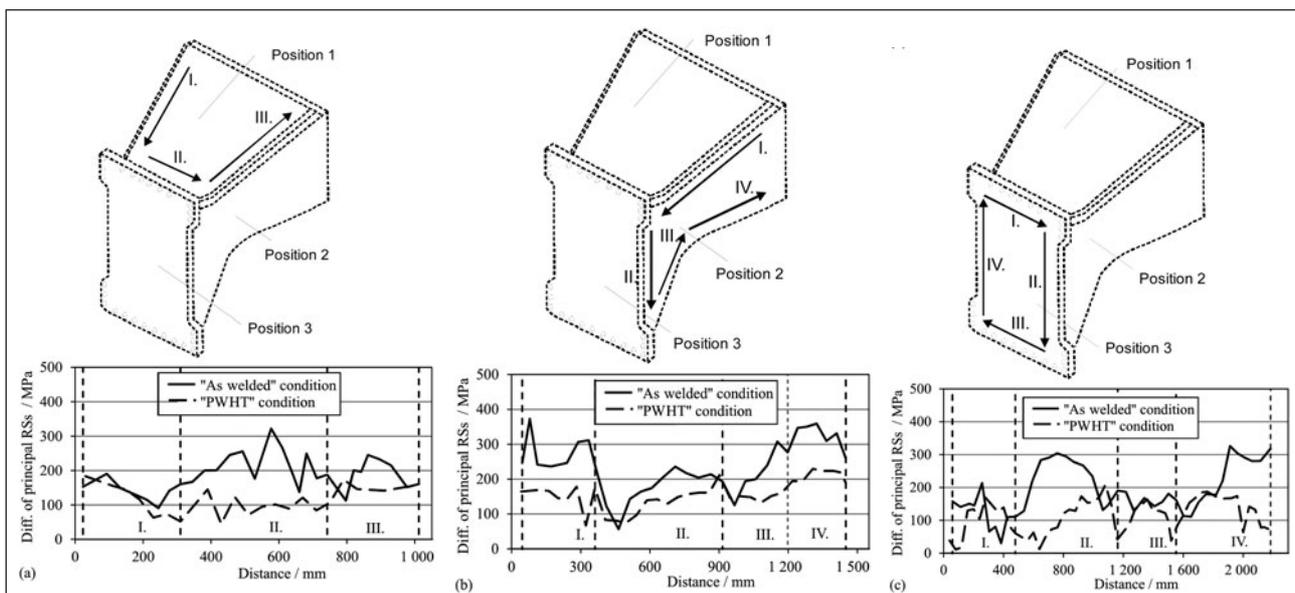
Figure 5 The results of RSs measurements in "as welded" and "PWHT" conditions; for position 1 (a), for position 2 (b) and for position 3 (c)

The influences of macro and micro RSs (I., II. and III. order) together are possible to be measured by the magnetic method, but only the differences of the principal RSs and their directions can be obtained. Figure 5 shows the results of RSs measurements on the connection part of the hinge joint at in the "as welded" and the "PWHT" conditions. The roman numbers in Figure 5 on the right side corresponds to the measurement paths, which are shown on the left side.

The important is the fact that relaxed RSs are as small as possible in "PWHT" condition in some special regions:

- at the position 1 in corners of paths (I. - II. and II. - III.),

- at the position 2 in the corner of paths (I. - II.),
- at position 3 in corners of paths (I. - II. and IV. - I.),

where the welds are cross each other and those parts of material are heavily dynamically loaded in exploitation. In those regions cracks started to appear on the most heavily loaded mobile transporters in practice, which did not use PWHT for relaxation of the RSs in the connection part of hinge joint. Appropriate results in Figure 5 in

those regions show that the RSs relaxed more than 50 % in differences between principal RSs after the PWHT. Hardness in those regions is also reduced by PWHT what influence on decreasing of impact toughness and increasing of the crack resistance of the material. The regime of the PWHT for relaxation of RSs is adequate and enables safe operations of the mobile transporter for liquid slag in future. In particular mobile transporter where crack appeared in exploitation, the connection part of the hinge joint was cut and replaced by new one which had been PWHT before. Another safety step which was performed in this mobile transporter are additional ribs which were welded in the positions where cracks appeared before in order to reduce the load and increase the safety and crack resistance of the material of the mobile transporter. Mobile transporter still works in exploitation without any problems.
